**Flood Control Project Maintenance  
Levee Inspections**

**Maintenance Issue Types Only, Levee Inspection Report By Mile - Fall 2016**

**Sutter Maintenance Yard East Levee Sutter Bypass**

Waterway	Bank	Unit Miles	Inspection Start/End	Inspector
Unit No. 01 Sutter Bypass Levee	Left	21.68	09/23/2016 09/30/2016	Tariq Chechi

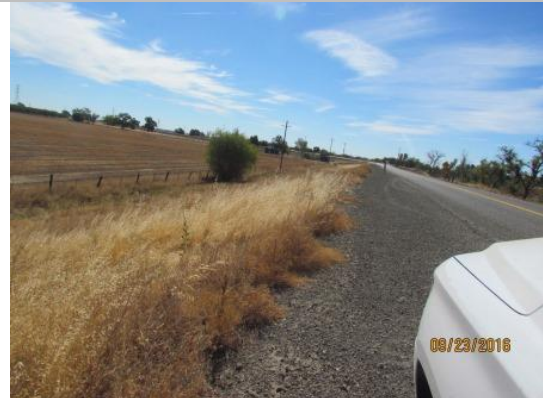
Photo 1 of 1 : FA\_2016\_ST0002\_450\_27\_20161003\_00044.jpg

View of the annual grass blocking visibility.

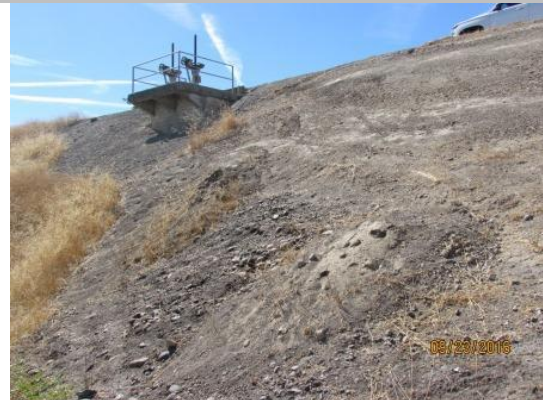
Photo 1 of 1 : FA\_2016\_ST0002\_450\_30\_20161003\_00045.jpg

View of the rodent holes along the landside slope.

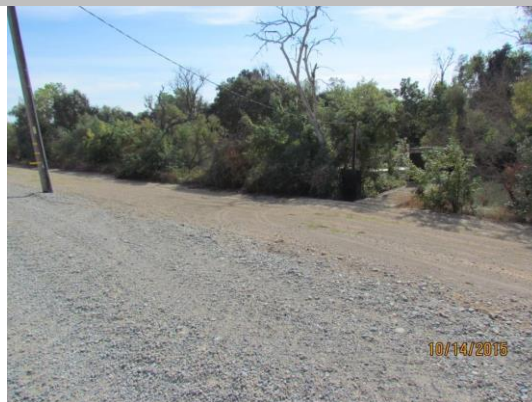
Photo 1 of 1 : FA\_2016\_ST0002\_450\_23\_20160823\_00004.jpg

LM Start	13.34	Rating **	A/W	Issue No.	23
LM End	13.34	Issue Type +	Ma	Location *	WS
Category	Earthen Levee			GPS Latitude/Longitude	
				Start	End
Item	Slope Stability			38.991857 °	38.991857 °
				-121.711555 °	-121.711555 °
DWR ID	DWR_ST0002_01_s_2015_23				
Comment Code					
S3 : Repair the levee slope damaged by vehicle traffic and prevent access where possible.					
Inspector Comment					
Repair the erosion along the waterside slope.

View of the vehicle erosion along the slope.

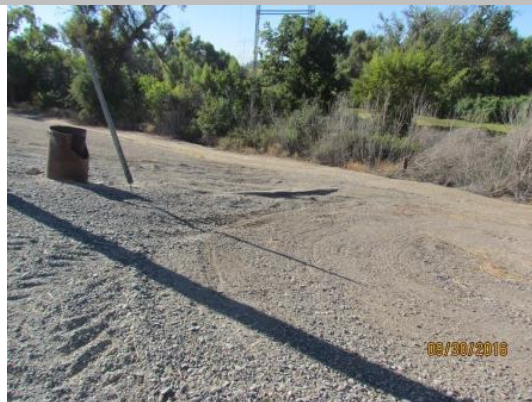
Photo 1 of 1 : FA\_2016\_ST0002\_450\_37\_20161003\_00050.jpg

LM Start	14.71	Rating **	M	Issue No.	37
LM End	14.71	Issue Type +	Ma	Location *	WS
Category	Earthen Levee			GPS Latitude/Longitude	
				Start	End
Item	Slope Stability			38.979389 °	38.979389 °
				-121.691923 °	-121.691923 °
DWR ID	DWR_ST0002_01_f_2016_37				
Comment Code					
S3 : Repair the levee slope damaged by vehicle traffic and prevent access where possible.					
Inspector Comment					
Repair the vehicle erosion along the waterside slope.

View of the erosion caused by vehicle traffic.

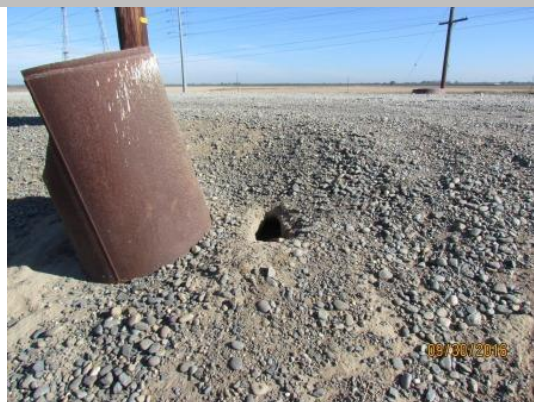
Photo 1 of 1 : FA\_2016\_ST0002\_450\_38\_20161003\_00051.jpg

LM Start	14.71	Rating **	M	Issue No.	38
LM End	14.71	Issue Type +	Ma	Location *	WS
Category	Earthen Levee			GPS Latitude/Longitude	
				Start	End
Item	Animal Control			38.979389 °	38.979389 °
				-121.691923 °	-121.691923 °
DWR ID	DWR_ST0002_01_f _ 2016_38				
Comment Code					
A3 : No rodents visible, but rodent burrows visible; need to backfill and compact or grout burrows.					
Inspector Comment

View of the rodent holes along the landside slope.

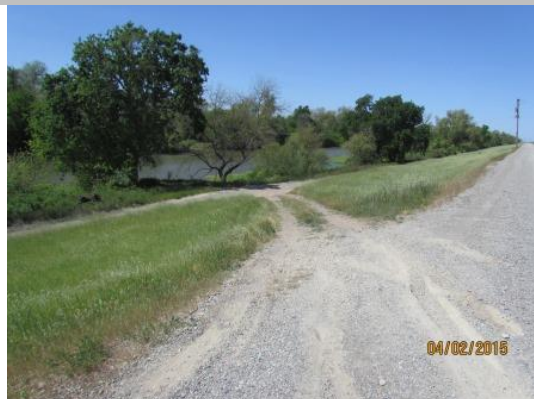
Photo 1 of 2 : FA\_2016\_ST0002\_450\_21\_20160823\_00002.jpg

LM Start	17.60	Rating **	M	Issue No.	21
LM End	17.60	Issue Type +	Ma	Location *	WS
Category	Earthen Levee			GPS Latitude/Longitude	
				Start	End
Item	Slope Stability			38.949965 °	38.949965 °
				-121.653823 °	-121.653823 °
DWR ID	DWR_ST0002_01_s_2015_21				
Comment Code					
S3 : Repair the levee slope damaged by vehicle traffic and prevent access where possible.					
Inspector Comment					
Repair the vehicle erosion along the waterside slope.

View of the vehicle erosion along the waterside slope.

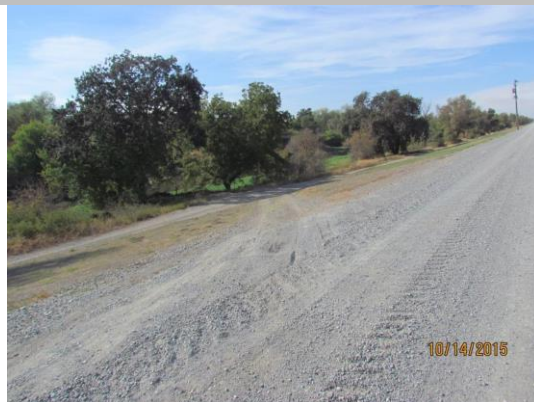
Photo 2 of 2 : FA\_2016\_ST0002\_450\_21\_20160823\_00003.jpg

View of the vehicle erosion along the waterside slope.

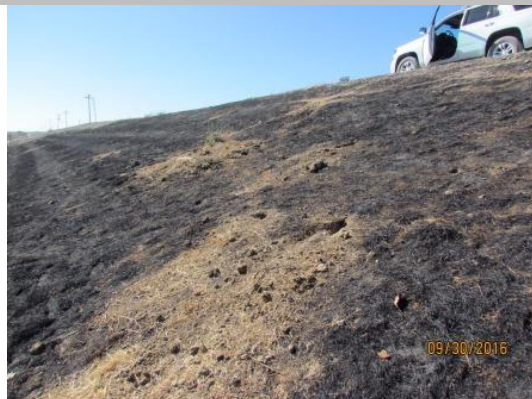
Photo 1 of 1 : FA\_2016\_ST0002\_450\_40\_20161003\_00058.jpg

LM Start	20.43	Rating **	M	Issue No.	40
LM End	20.43	Issue Type +	Ma	Location *	LS
Category	Earthen Levee			GPS Latitude/Longitude	
				Start	End
Item	Animal Control			38.916965 °	38.916965 °
				-121.624048 °	-121.624048 °
DWR ID	DWR_ST0002_01_f_2016_40				
Comment Code					
A1 : Exterminate rodents and backfill and compact or grout burrows.					
Inspector Comment

View of the rodent holes along the landside slope.
